STAR ONLINE PUBLICATION

Case Number: S2023000005 Rev A

Symptom/Vehicle Issue: Water Leak On Sliding Rear Window Or Back Of Cab

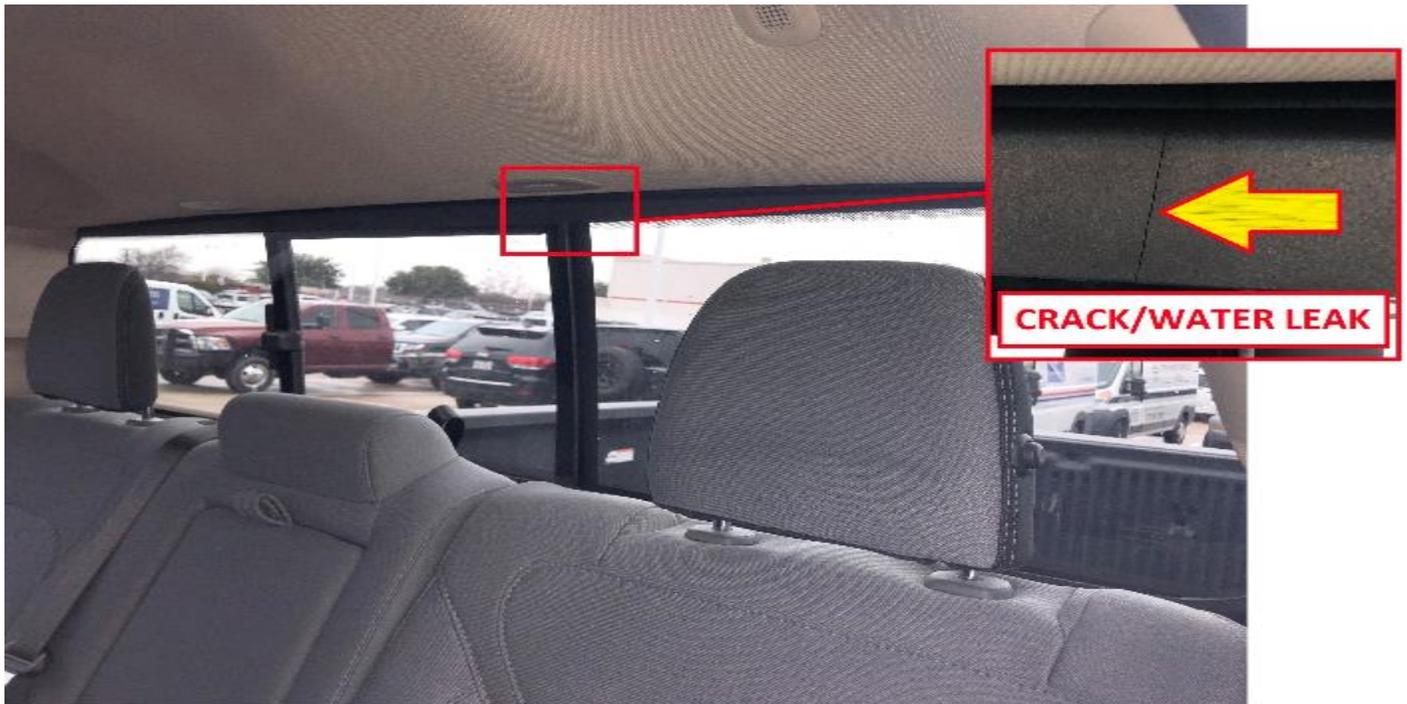
Discussion: Inspect rear window frame for any signs of cracking. Any cracks found will require replacement of the rear window assembly.

Example of a crack

Parts Information: If replacing the rear window assembly, use Mopar parts with packaging dated after 11/26/2020.
